Manhole Inspection Summary

Manhole # S33G__006MH

Insp Date: **8/14/08 11:34 AM**

Location Address: **20 n hanover st**

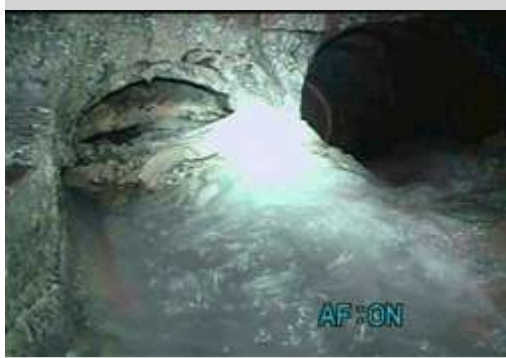
Defect 2

Condition: ☐ Sound ☐ Cracked ☐ Root Intrusion ☐ Deteriorated ☐ Leaks ☒ **Debris**

channel debris

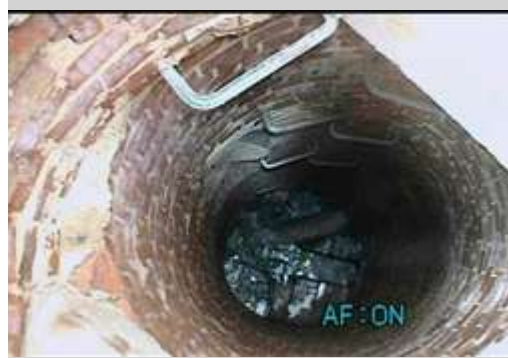
Defect 1

Count: **9** Missing: **0** ☒ **Corroded**

corroded steps

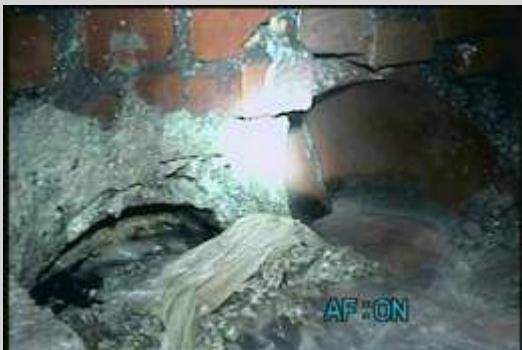
12 O'Clock Outflow

pipe on left is closed off and the one on the right is the 12
